## ASSESSMENT OF TECHNOGENIC RISKS IN RECOVERING COMPANY FOR WORN TYRES

Riga Technical University, Latvia

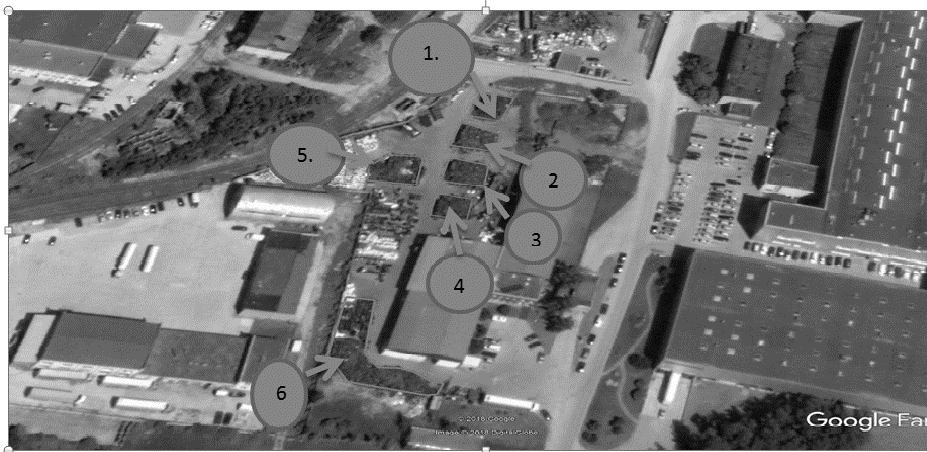
Fig. 1. Tyre housings 1 – 6 in object territory

Tyre housings are not mutually separated by special enclosures, so in the event of a fire in one of the housings the effect of heat radiation can lead to ignition of also other nearby buildings with tyres or the finished products – crushed rubber residues with a lower ignition temperature than the tyres. There may be a domino effect, if no measures are taken to relocate other materials being in the housings. All substances and materials stored in the object territory are potential sources of energy which, in the event of fire, generate heat. The heat of rubber combustion is  $33.5 \text{ MJ}\cdot\text{kg}^{-1}$  [12]. In case

- The maximum size for the housing is not exceeded, but the distances at the storage from the housing edge to the fence and buildings are not observed, because the tyres are stacked immediately at the fence instead of 15 m as specified; the building where tyres are being recycled is in the immediate vicinity and not 60 m away. Firebreaks of 18 m between housings are not observed.

In order to reduce the object's hazard associated with open-area storage of tyres, the authors propose a US example of good practice regarding the temporary storage of tyres [14]. As well as recommendations in the New Zealand's guidelines on the prevention and management of scrap tyres that it is possible to reduce the risk of fire and the possible domino effect between tire housings by setting minimum distances between the tyre housings [15]. In addition, the authors' group
