MODERNIZATION OF STRUCTURAL DESIGN OF OP-2000 SPRAYER USING APM WINMACHINE CAE SYSTEM

Abstract. The work is devoted to the modernization of the strain scheme of the sprayer OP-2000 frame preventing the destruction and residual deformation of the longerons using the CAE APM WinMachine system. The purpose of the research is to identify the causes and search for solutions to prevent identified failures. The problem is solved by constructing a finite element model of the structure and analyzing its stress-strain state using the Structure 3D CAE-system APM WinMachine calculation module and comparing the results with field sample activity. To determine the geometry of key structural elements, as well as adequate modeling of fastenings and proper load distribution, a 3D model of the sprayer frame has been built. For numerical experiments a complex plate-rod model has been developed, which allows accurately to reflect the geometry features of the structure and location of the supporting surfaces, the parameters of the partition grid were selected in such way to simulate adequately the loads. As a result of the calculations it was found that the cause of the frame longeron destruction is a

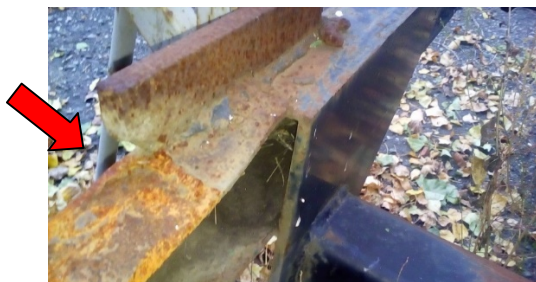
The operating experience of this technique allows us to characterize it as reliable and low-maintenance. However, during the operation of the OP-2000 in farms they faced with characteristic failures associated with the destruction and deformation of the sprayer frame (Figures 1-2). Failures are observed after transporting a fully refilled sprayer to the field along field roads.

Fig. 1. Longerons destruction

All detected defects are critical, i.e. they exclude the use of the machine for its intended purpose in accordance with the requirements of the operational documentation.

Analysis of the obtained stress map (Figure 5) shows that the maximum level of stress occurs in the zone of attachment of the jaw of the middle beam, where the frame breaks down.

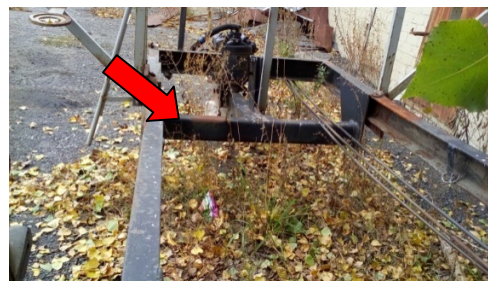
Fig. 2. Frame deformation

Stability calculation was carried out under the static action of the load (without taking into account the inertia forces from the gravity force acceleration), when the strength is still provided, although with the minimum allowable safety factor (1.14). Moreover, the stability margin also has a very small value (1.08) and the form of stability loss corresponds to the strain pattern in Figure 5. Thus, the place of stability loss coincides with the actual place of residual deformations on the sprayer frame (Figure 2), which also confirms the reliability of the calculations.

Thus, the obtained results in comparison with the real fracture pattern demonstrate good convergence of the results, which confirms the adequacy of the constructed model. The analysis of the stress-strain state picture shows that the design does not provide enough margin of safety under conditions of additional loading by inertia forces under acceleration along the vertical axis. According to the calculation results, the observed residual deformations of the sprayer frame can be explained

either by the loss of longeron stability, or by the construct falling into resonance [10] at a frequency of about 24 Hz.

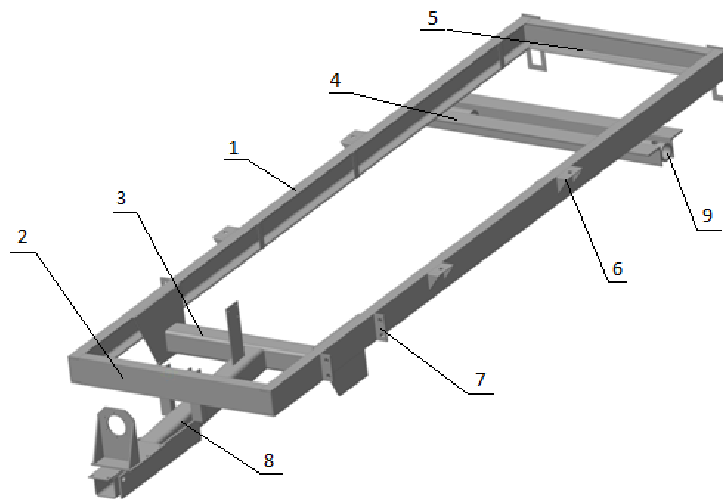
We built the model in the CAD system KOMPAS 3D. To do this, according to the results of measurements of the frame full-scale sample, the models of individual parts were built and then the resulting parts were combined into an assembly (Figure 3).

Fig. 3. **3D model of the sprayer frame:** 1 – longeron; 2 – front traverse; 3 – middle traverse; 4 – traverse of carrier wheels; 5 – rear traverse; 6 – tank mounting bracket; 7 – service platform mounting brackets; 8 – drawbar; 9 – clip of fastening of a wheel semiaxis

As a result of the analysis of the real structure, as well as its 3D models, the points of application of loads to the frame, as well as their power, were established. The loads on the frame are composed of gravity from the tank with full refueling (21840 N), which is decomposed into four platforms along the upper shelf of the longeron channel section (pos. 1 Fig. 3). The bearing pads are located symmetrically at the middle traverse jaw (pos. 3, Fig. 3) in front and above the front corner of the rear traverse of the carrier wheels (pos. 4 Fig. 3). According to these sites, the force is distributed evenly -

In addition, on the side surfaces of the longerons, we fixed the tank mounting brackets (pos. 6 Fig. 3) and service platform mounting brackets (pos. 7 Fig. 3), which also have to be under loading. The tank mounting brackets are affected by the tightening forces of the bolts of the clamps that surround the tank. These forces are directed upwards and amount to 1500N for each bracket. The efforts are determined from the moment of tightening the nuts of the clamps given in the operational documentation [5].

The rear traverse (pos. 5 Fig. 3) is loaded with the gravity of the frame of the hitching boom of the sprayer. This load falls in the middle of the rear beam and is 2700 N.

As supports we take the front point of the drawbar beam (pos. 8 Fig. 3) of the sprayer frame and two clips of the wheel axle mounts (pos. 9 Fig. 3) on the rear traverse of the support wheels.

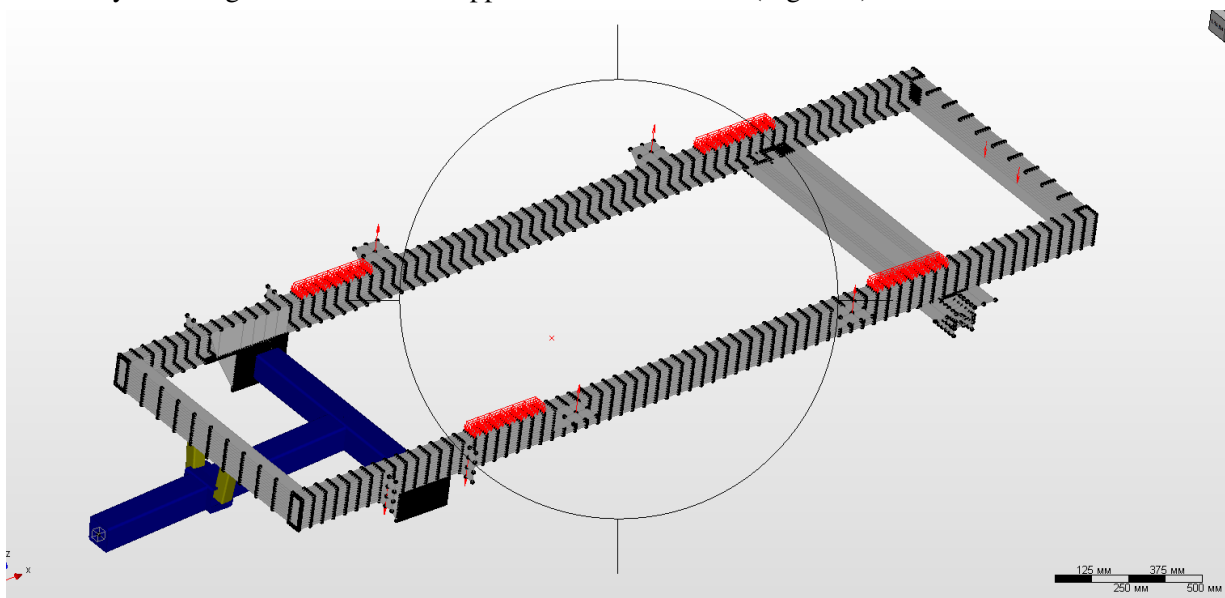
We have created a combined plate-rod finite element model that allows us to demonstrate accurately the design features and the application of loads to it (Figure 4).

Fig. 4. Plate-rod finite element model

In this model longerons and traverses (except the front one) are modeled by plate elements of the corresponding thickness divided by a grid of nodes into separate components. The partition grid parameters were selected in such way as to subsequently more accurately simulate the application of loads.

The front traverse and drawbar beam were modeled with rods due to the features of loading and fastening of these elements.

Figure 4 also demonstrates the simulated side brackets and the loads to the structure in the form of separate forces to the nodes and forces distributed across the plates.

Fastenings in the form of articulated-fixed supports are installed at the end of the drawbar beam and at the ends of the traverse of the axle shafts of the wheels.

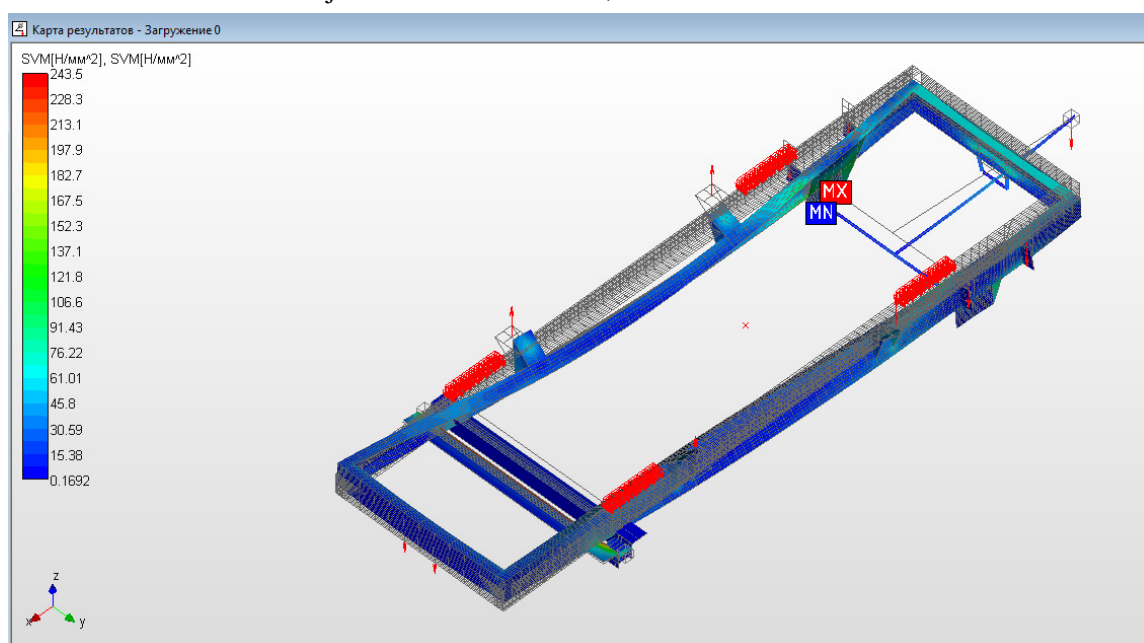
Fig. 5. Map of maximum principal stresses

The maximum value of the emerging principal strains of 240 MPa exceeds the permissible value for steel 20, of which the frame is made.

Analysis of the stress map and the displacement map obtained during the calculation shows that the observed situation is due to the implemented loading scheme, namely, the applied load from the refilled tank over two sites on the upper shelf of the channel of each frame longeron. Not really high frame rigidity in the middle section without transverse elements (traverse) plays a significant role.

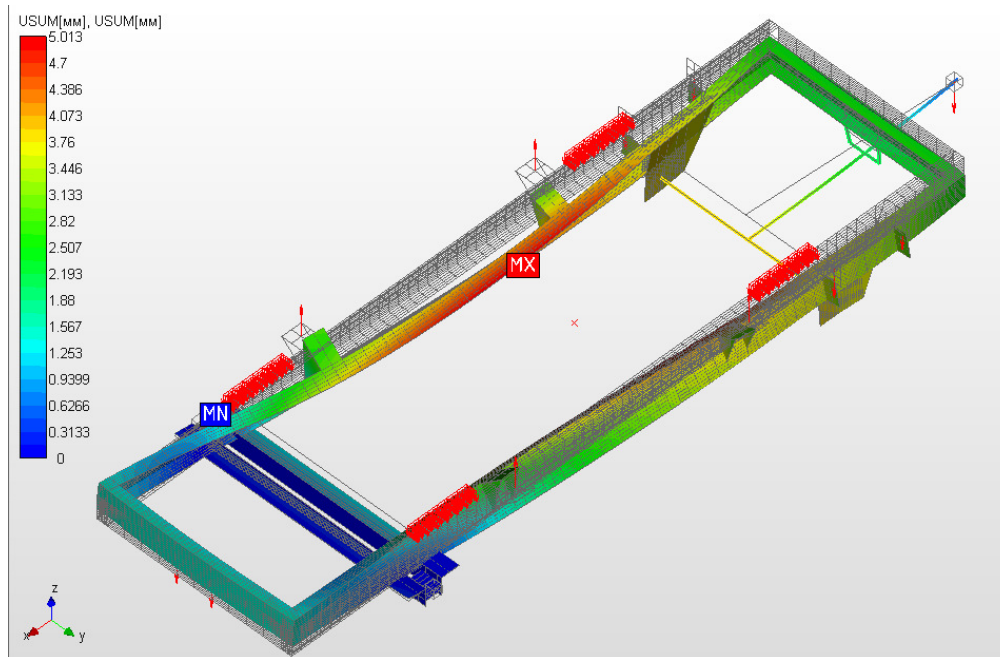
The frame distinctive deformation is also noteworthy. The maximum displacement value (Figure 6) is 5 mm. This displacement itself cannot be considered excessive for the given dimensions of the frame, so we can say that, if the strength was provided, then the rigidity would be sufficient.

Fig. 6. Displacement map

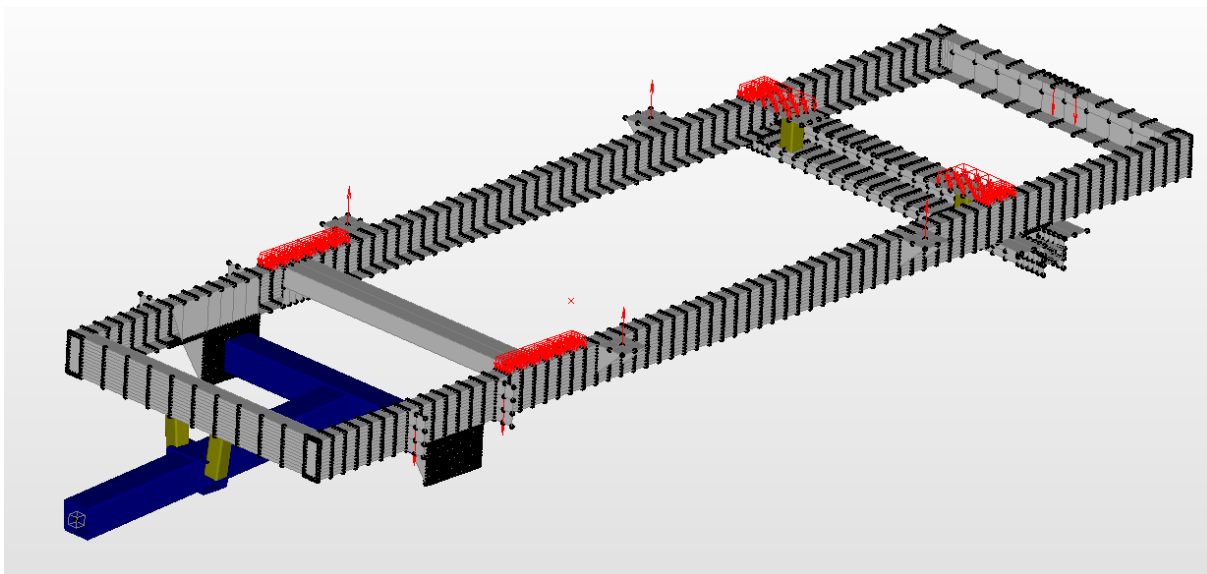
We proposed in the rear part of the frame to install additional platforms, which can redistribute part of the pressure from the tank. At the same time, in order to remove part of the load from the longerons and transfer it to the traverse of the wheel mounting, a stand was installed under the additional platform connecting the platform to the traverse (Figure 7).

Fig. 7. Upgraded Frame Model

To increase the frame rigidity in the middle section it is proposed to install an additional transversal element. Structurally an additional traverse can be installed on the longeron side with 350 mm long from the attachment point of the drawbar jaw. This length of the section is due to the fact that at a distance more than 350 mm from the attachment place of the jaw between the frame longerons there are structural elements of the tank.

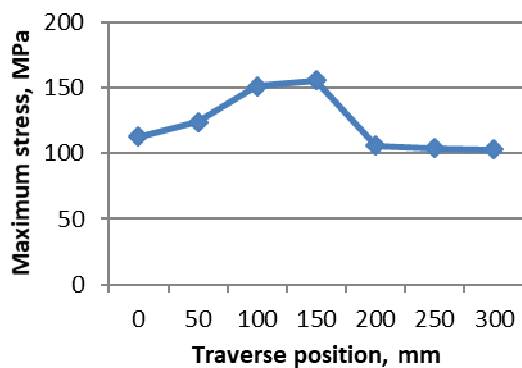
The obtained dependences are presented in Figure 8 and Figure 9.

As it can be seen from the figures, the installation of additional elements on the frame itself significantly reduces the maximum level of acting strains. In this case, the removal of the additional traverse from the attachment point of the jaw leads first to a certain increase in the level of the maximum primary stress and then to its decreasing to the level of 103-105 MPa. The maximum deformation of the structure is monotonously reduced.

Fig. 8. Maximum primary stress change

Thus, the calculations have shown that the optimal installation location of the additional traverse is a distance of 200 mm from the jaw attachment point of the intermediate traverse of the sprayer frame.

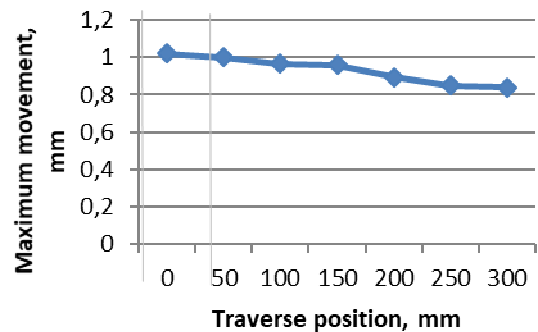
Fig. 9. Maximum displacement change

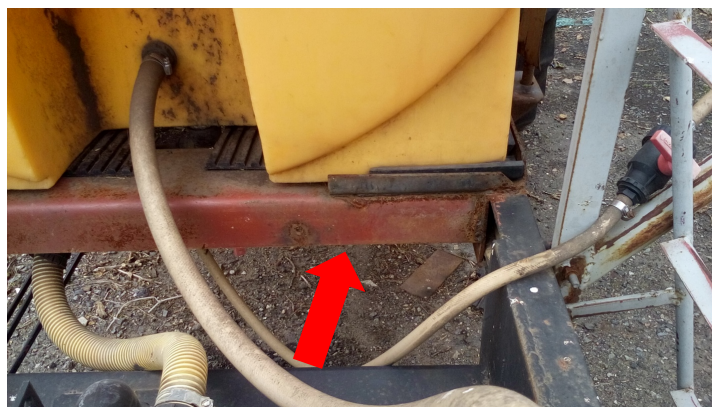
In accordance with the measures to modernize the design of the OP-2000 sprayer frame in the conditions of Maznev farm one unit of the specified equipment was repaired. After field work the sprayer was disassembled. The frame defect identification revealed a failure in the form of permanent deformation of the right longeron. After frame reconstruction between longerons in the determined place an additional intermediate traverse (Figure 10) was welded from a bent channel 140x80 and base plates were welded on it.

Fig. 10. Installed additional traverse

In operation of the modernized sprayer during the field season of 2018 in the same modes as before the reinforcement of the structure, no failure of the frame was recorded due to previously observed defects.

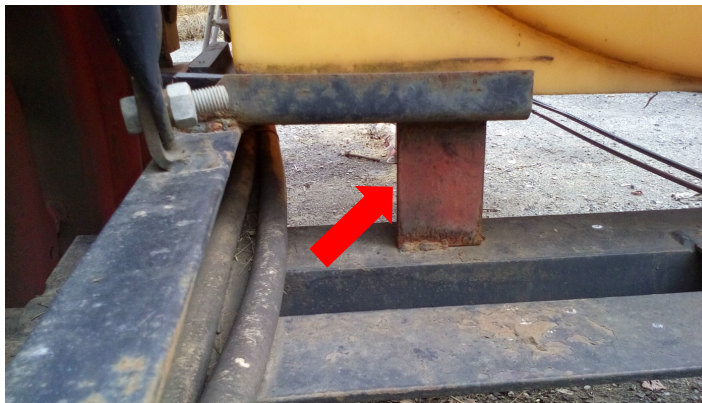
Further support platforms were welded to the right and left longerons and racks were welded between them and the wheel traverse (Figure 11).

Fig. 11. Installed left mounting pad with support
