## DEGRADATION OF COATINGS IN CAR REPAIR

**Abstract.** In the automotive industry, respectively in car repairs, we often meet with the need to repair the car body. During the repairs it often extends to the original grinding Zn layer base material – sheet. The paper aims to analyze the degradation of the protective coatings by car repairing after corrosion by a salt environment of the corrosion chamber. The subject of the interest is water-based coatings on steel sheet samples, where they will be one half of the Zn surface layer maintained and the other half of the Zn layer grinded. The material samples examined in several periods exposed to the salt spray in the corrosion chamber. After loading their corrosion resistance will be evaluated of the resistance of the paint coating of the applicable CSN EN standards. At the end of this paper conclusions are drawn and resulting recommendations are presented.

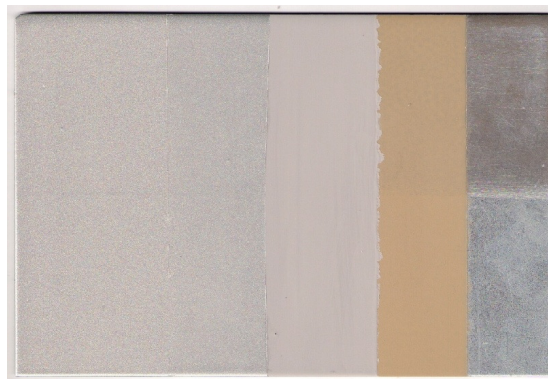
Surface sampling was conducted using coating system for repair of protective coatings of paint car body from the German company Glasurit. The coating system was applied to the base material according to the technological progress and technical data sheets of the manufacturer. The formation of the protective layer of lacquer was applied with used water-soluble base covered with a layer of clear coat. The whole procedure applying the coating system was divided into four basic steps: degreasing the surface of the sample application without chrome base, pore filler application, final application layer, Fig.1.

**Fig. 1. Preparation of the experimental sample, step by step**

- Stain Remover – KH-Entferner 541-5
- Basis of chromate-free – Echt Primer 283 to 150
- Basis of chromate-free – Como Fuller 285-88
- Water-soluble base – Series AH 90, Tint metallic silver Skoda 9102
- Top clear coat – HS – Universal Klarlac VOC-923-33

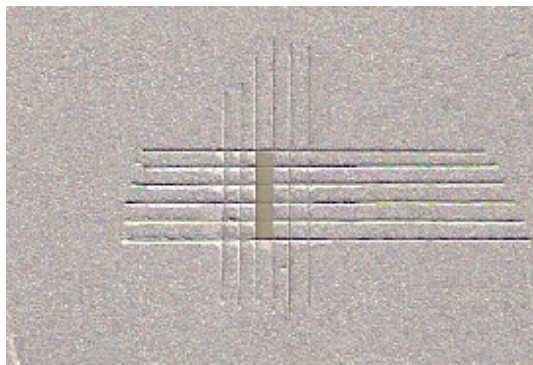
The cross-cut test is used to evaluate the durability of paint peeling from the substrate. It is a further possibility of visual evaluation of the surface samples. The grid standard CSN EN ISO 2409 determines performing the test. For the samples fitted with water-based metallic coating (M1 to M6), there was no defect, and therefore almost all samples were assessed as 0. Only the sample M2a was negligible. Department of the surveyed grid area is probably because of local defects in the coating, Fig. 2, in this case, also with separate metallic filler and lacquer base from scratch.

Fig. 2. Paint peeling off after the grid test, sample M2a

The samples provided with the metallic coating layer Zn showed no damage after the test grid, the exception was the sample of M2a, where there was a small defect grid, respectively its partial separation from the substrate. This defect could be caused by the presence of dirty (oily) sites generated during sample handling. Zero degree of damage to the grid was also classified by areas from which the zinc coating polished. In terms of the grid test there is no difference in the behavior of the protective layer deposited on the zinc layer and grinding layer of zinc.
